## 7. The August 14 Blackout Compared With Previous Major North American Outages

### Incidence and Characteristics of Power System Outages

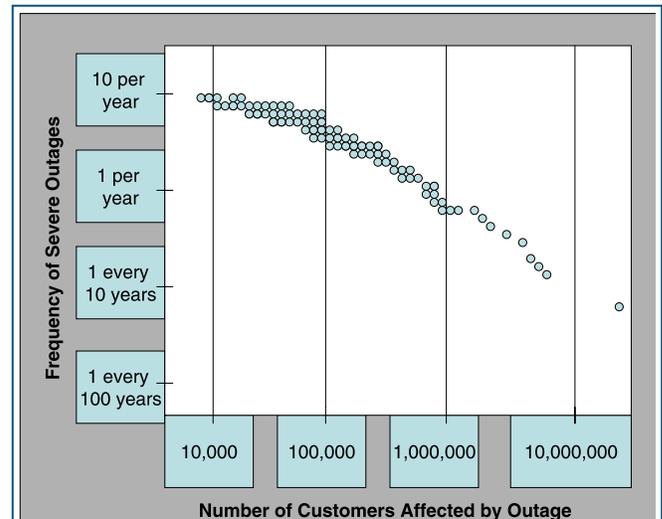
Figure 7.1. North American Power System Outages, 1984-1997

Note: The circles represent individual outages in North America between 1984 and 1997, plotted against the frequency of outages of equal or greater size over that period.

If nothing else changed, one could expect an increased frequency of large-scale events as compared to historical experience. The last and most extreme event shown in Figure 7.1 is the August 10, 1996, outage. August 14, 2003, surpassed that event in terms of severity. In addition, two significant outages in the month of September 2003 occurred abroad: one in England and one, initiated in Switzerland, that cascaded over much of Italy.
